**Stanford Townhomes Homeowners' Association
c/o Willamette Community Management
PO Box 514, Corvallis, OR 97339-0514**

Re: Notification of construction defect

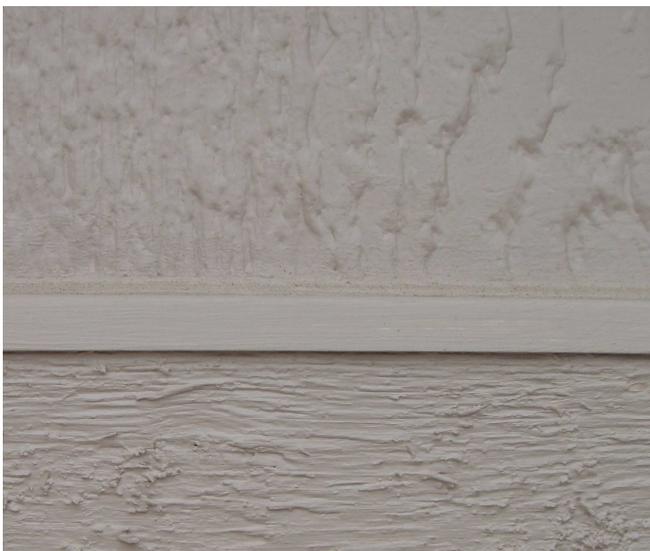
Below are photos that show a window with "Z" flashing (left) and one without (right). The "Z" flashing is the small thin strip of metal above the upper trim piece.

Explanation: The "Z" flashing is a piece of sheet metal that is supposed to be installed above every door and window that is bordered with trim pieces. The flashing is supposed to be mounted over the top edge of the upper trim piece in these applications. When water flows down the siding during rain, the properly installed "Z" flashing directs water outside, instead of allowing it to flow under the trim piece and behind the flange of the window and inside the wall. This problem affects all the windows and doors that do not face the courtyard area. Some units will be more susceptible to leakage due to their orientation to the wind and rain, but ultimately, over time any of the units could start to leak.

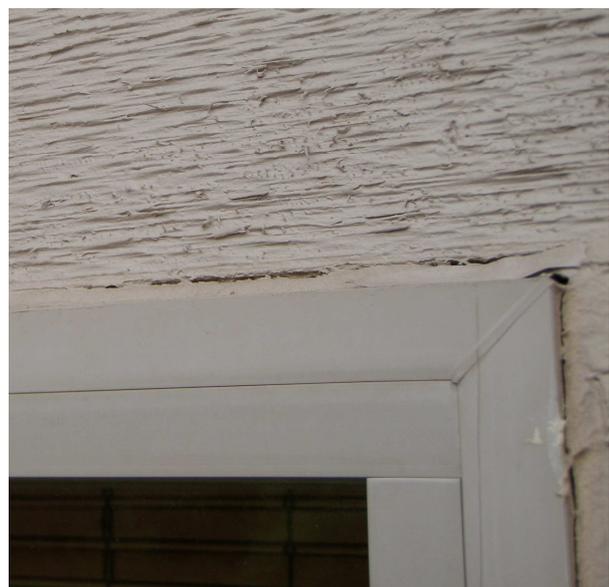
There is a construction defect in some windows and doors which affects all units within Stanford Townhomes. A critical "Z" flashing was omitted during the installation of windows and doors during construction resulting in some units experiencing moisture leaking into the walls of the buildings.

- 1) Each individual Owner could repair the defect of his/her own windows & doors; use of a licensed contractor is recommended.
- 2) Each individual Owner could pursue a claim with the Seller/Builder; professional legal advice is recommended.
- 3) Owners could coordinate with one or more other owners to affect a repair; generally it is more cost effective to have more defects repaired at the same time with the same contractor than individually employing separate contractors at different times.
- 4) Owners could coordinate with one or more other owners to pursue a legal notification of the problem to the Seller/Builder and to learn what remedy the Seller/Builder might affect. If there is no satisfactory remedy, then to determine if a claim should be pursued (i.e., Small Claims Court).
